Manhole Inspection Summary

Manhole # S13CC_003MH

Location Address: **2901 WINCHESTER ST**

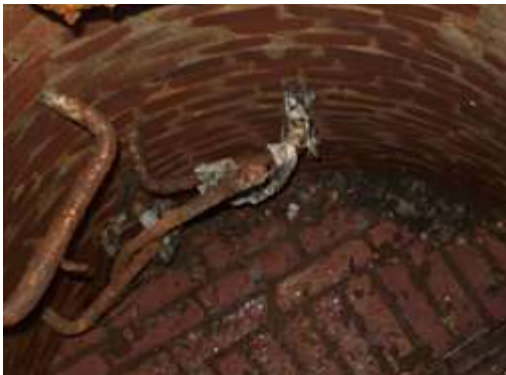
Defect 2

Condition: ☐ Sound ☐ Cracked ☐ Root Intrusion ☐ Deteriorated ☐ Leaks ☒ **Debris**

debris in channel

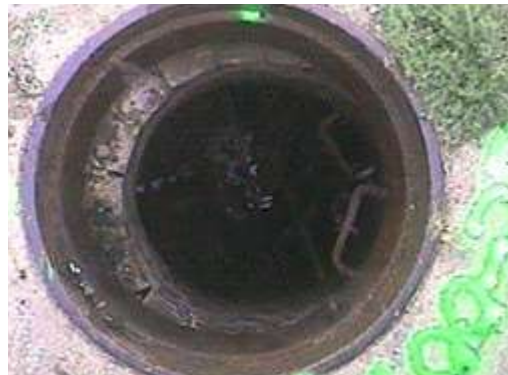
Defect 1

Count: **4** Missing: **0** ☒ **Corroded**

☒ **Evidence Of Surcharge** Depth: **3** (ft.) ☐ Active Surcharge Present

evidence of ASUR and corroded steps

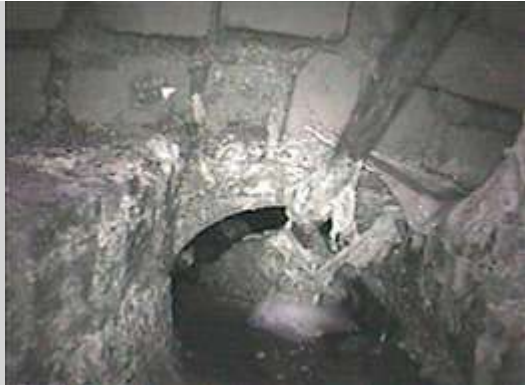
12 O'Clock Outflow

DEBRIS AT CHANNEL

Pipe Height: (in.) Direct
Pipe Material: **Clay** ☐ Pipe Lined
Invert Depth: **8.23** (ft.) Flow Characteristics: **Slow**
Deposits: ☐ None ☐ Mud ☒ Sludge ☒ Debris ☒ Grease
Silt Depth: **4** (in.) Deposits Extent: **Medium**
Infiltration: **None** Pipe Seal Cond: **Unknown**

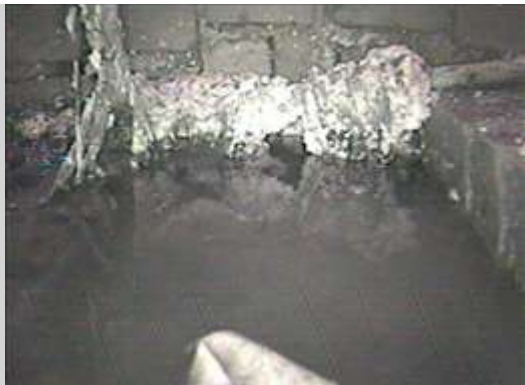
6 O'Clock Inflow

Pipe Height: (in.) Direct
Pipe Material: **Clay** ☐ Pipe Lined
Invert Depth: **8.18** (ft.) Flow Characteristics: **Slow**
Deposits: ☐ None ☒ Mud ☒ Sludge ☒ Debris ☐ Grease
Silt Depth: **6** (in.) Deposits Extent: **Heavy**
Infiltration: **None** Pipe Seal Cond: **Unknown**
